Review of Historic and Recent Water Quality in Stony Creek

Overview of the research and results

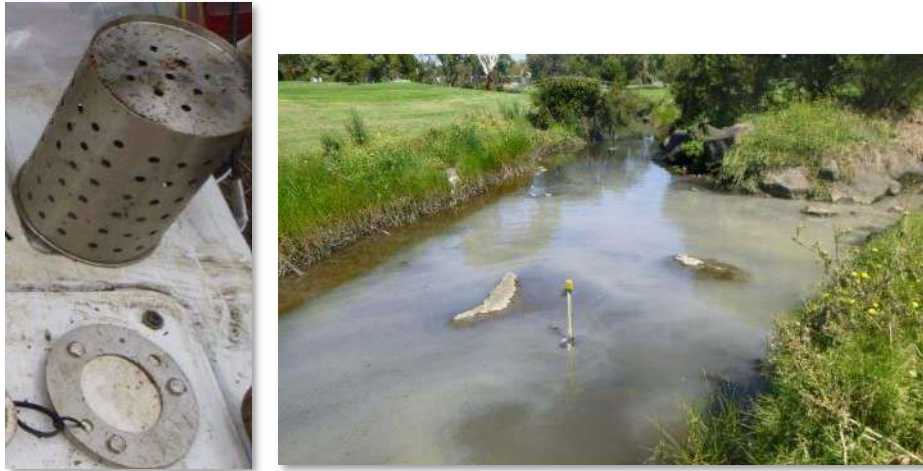
Figure 2. Polar Organic Chemical Integrative Sampler (POCIS) passive sampler and stainless steel cage. Passive samplers are used to measure water soluble contaminants, and are deployed instream, attached to a steel picket.

A recent monitoring program by AQUEST in 2021 used passive samplers to detect several organic compounds (pesticides and pharmaceuticals) within the water column of Stony Creek. Passive samplers are devices that can provide a time-integrated measurement of micropollutants in water (Figure 2). For this study we used Polar Organic Chemical Integrative Sampler (POCIS) passive samplers to measure organic chemicals and pharmaceuticals (including antibiotics, antidepressants, beta blockers, analgesics) in water. The samplers were deployed instream for up to 4 weeks at all Stony Creek sites (but not deployed in stormwater drains).

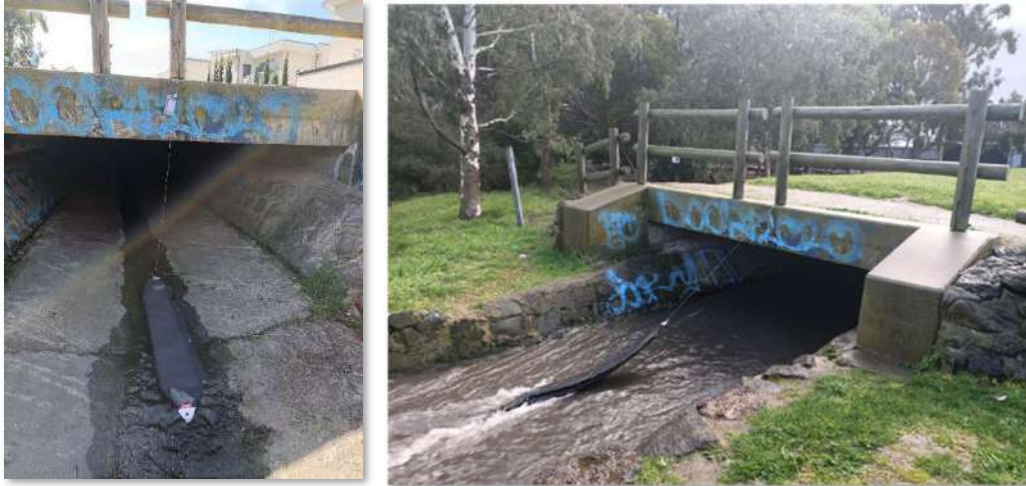
Figure 4. Sediment bag deployed in Graingers Rd Main Drain (Charlotte St). Sediment bags are tethered to structures in stormwater drains using wire cables and trap sediment particles from stormwater.

The AQUEST sampling program in 2021 utilised sediment bags that were deployed in stormwater drains to trap sediment particles from stormwater (Figure 4). Using this approach, several contaminants were detected at high frequency and/or concentration in sediments derived from stormwater, including **metals, pesticides** and TPH (Table 2). **Total petroleum hydrocarbons** were consistently detected in sediments throughout the catchment, whilst the metal concentrations tended to be higher in sites between Tottenham Stores MD and Francis St MD, rather than at Sunshine MD (top of catchment), or the Yarraville MD (bottom of catchment). Pesticide presence throughout the Stony Creek catchment was much lower and patchier than metals presence, and often only one site displayed detectable concentrations. **This work demonstrates that stormwater drains are an important source of contaminants to the catchment.**
