Coliban Water Monitoring Program

Monitoring Program for Assessing the Benefits of Environmental Offsets on the Condition of the Campaspe River: Year 1 (2018-2019)

Technical Report #22
December 2019

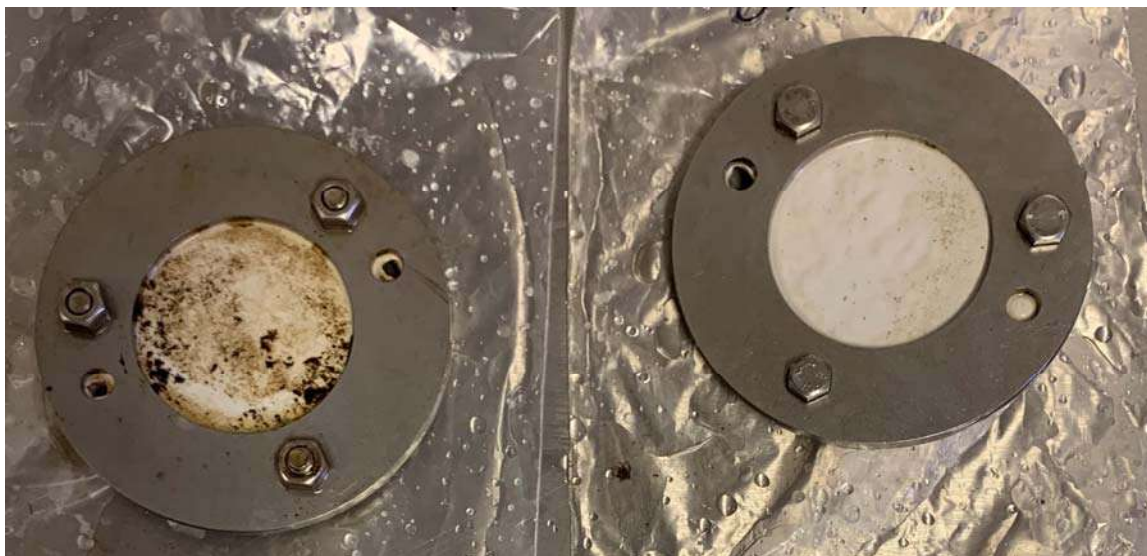
Plate 6: POCIS passive samplers following retrieval

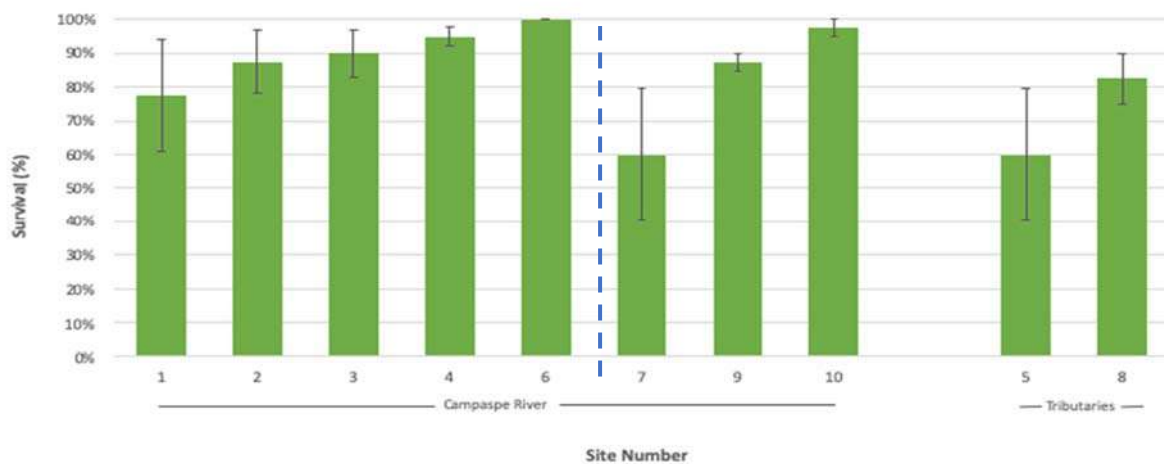
Figure 15: Mean survival (\pm SE) of mud snails, *P. antipodarum*, across sites during November 2018. Blue dashed line indicates Kyneton WRP discharge point between Sites 6 and 7.

Survival of the mud snail, *P. antipodarum* (Figure 15), did not differ across sites (Kruskal-Wallis, $H=12.188$, $DF=9$, $p=0.203$). Average survival was highest at Site 6 (100%), and lowest at Sites 5 and 7 (both 60%), with the reference sites (Sites 1 and 2) 78% and 88%, respectively.
